# **Noise Disturbance along Highways**

**Appendix: Section 2  
Traffic noise propagation  
through montane rainforest**

## Appendix 2.1 – 2005 Noise Transect Profiles

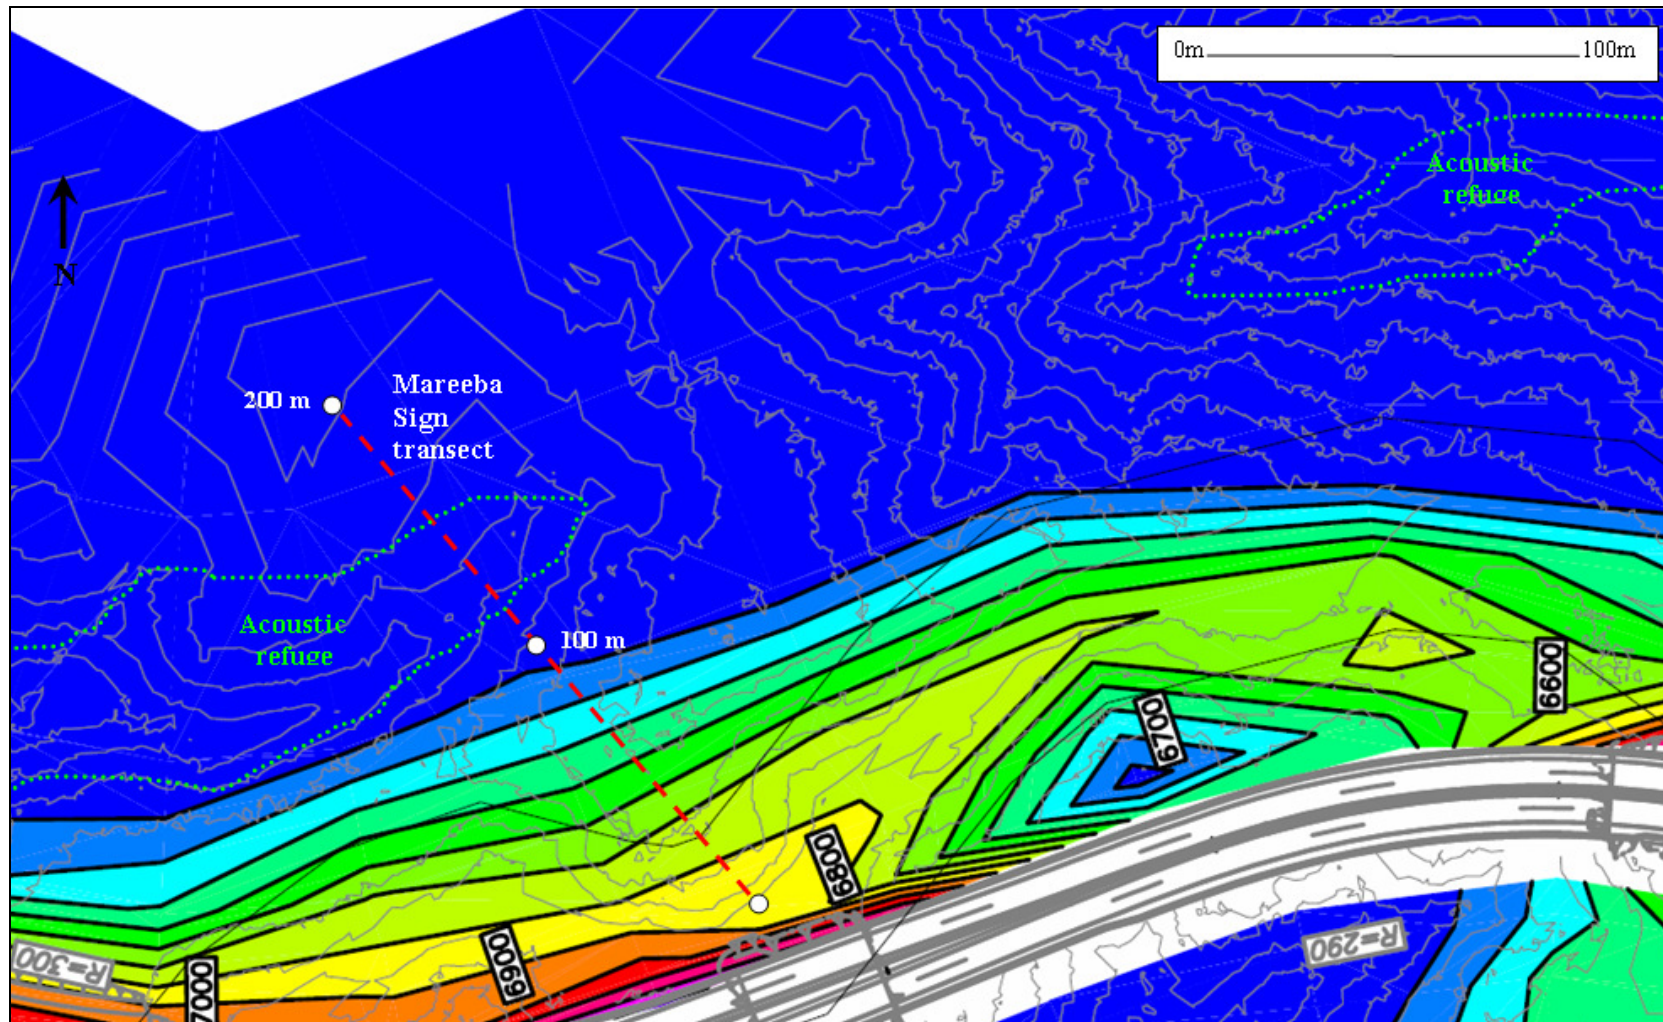
**Figure A2.3.6:** Acoustic refugia adjacent to Kuranda Range Road, north-south ridge, Macalister Range, (modified from ASK Consulting Engineers 2867FIGA, C6, 2003).

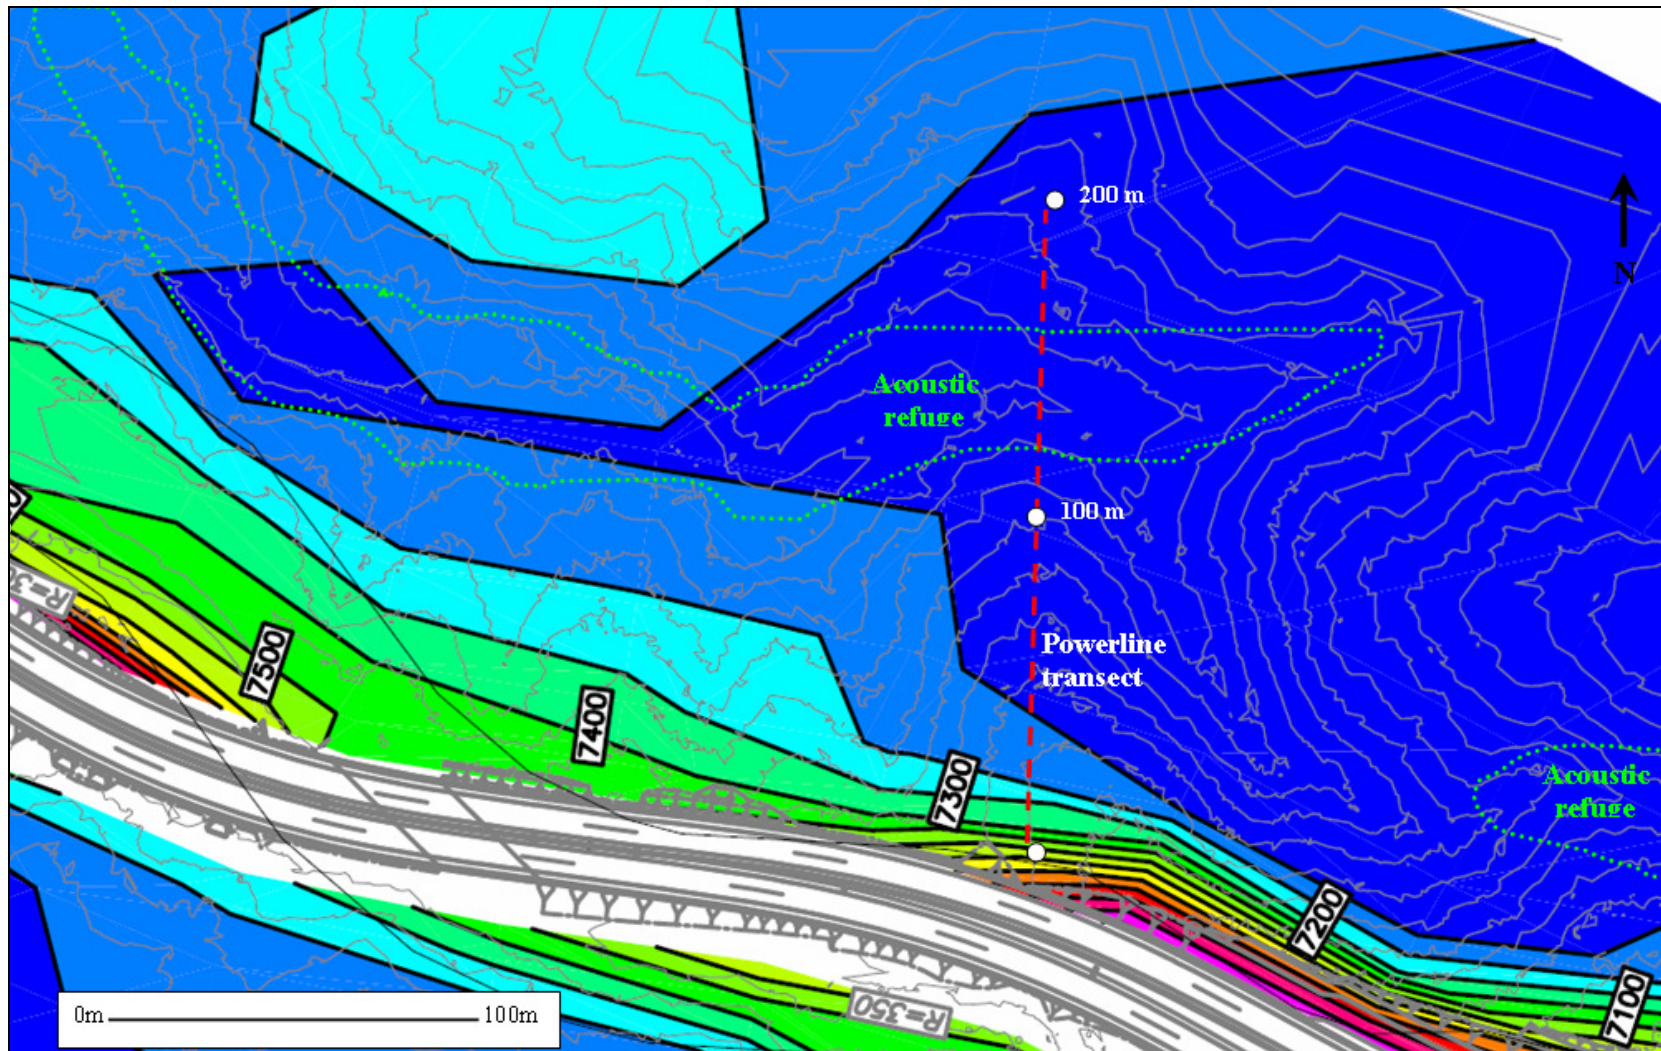
**Figure A2.3.7:** Acoustic refugia adjacent to Powerline transect, Kuranda Range Road (modified from ASK Consulting Engineers 2867FIGA, C5, 2003).

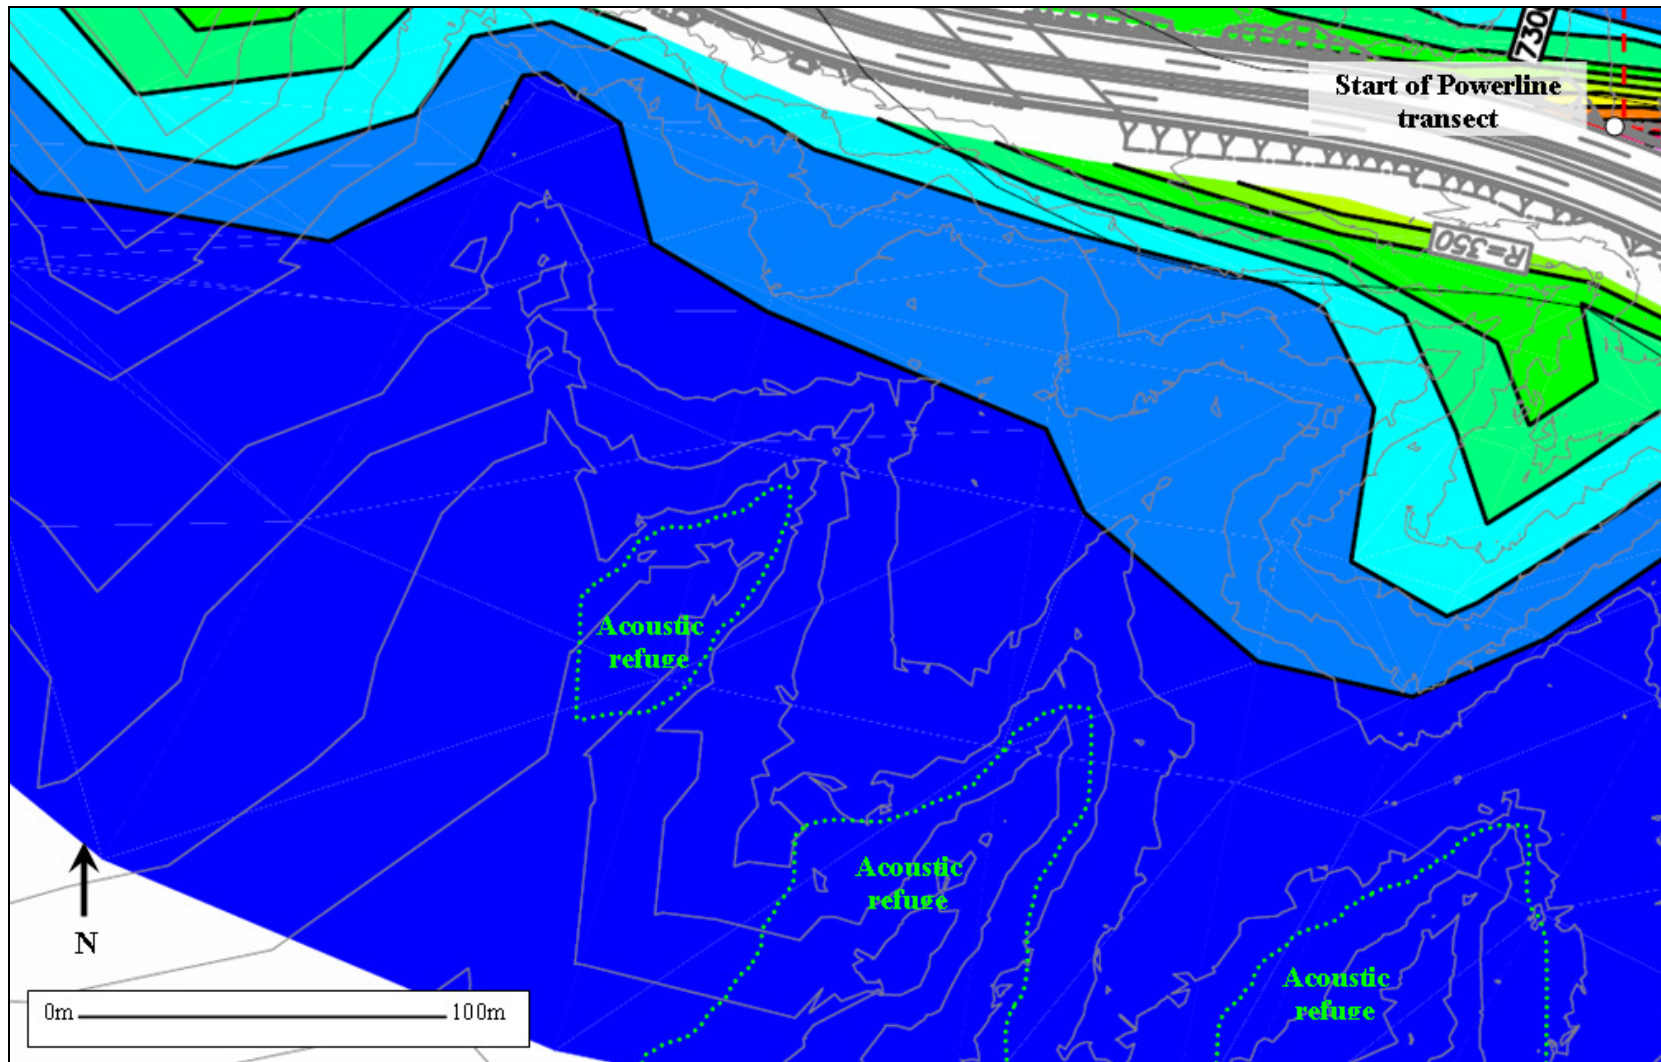
**Figure A2.3.8:** Acoustic refugia opposite Powerline transect, Kuranda Range Road (modified from ASK Consulting Engineers 2867FIGA, C5, 2003).

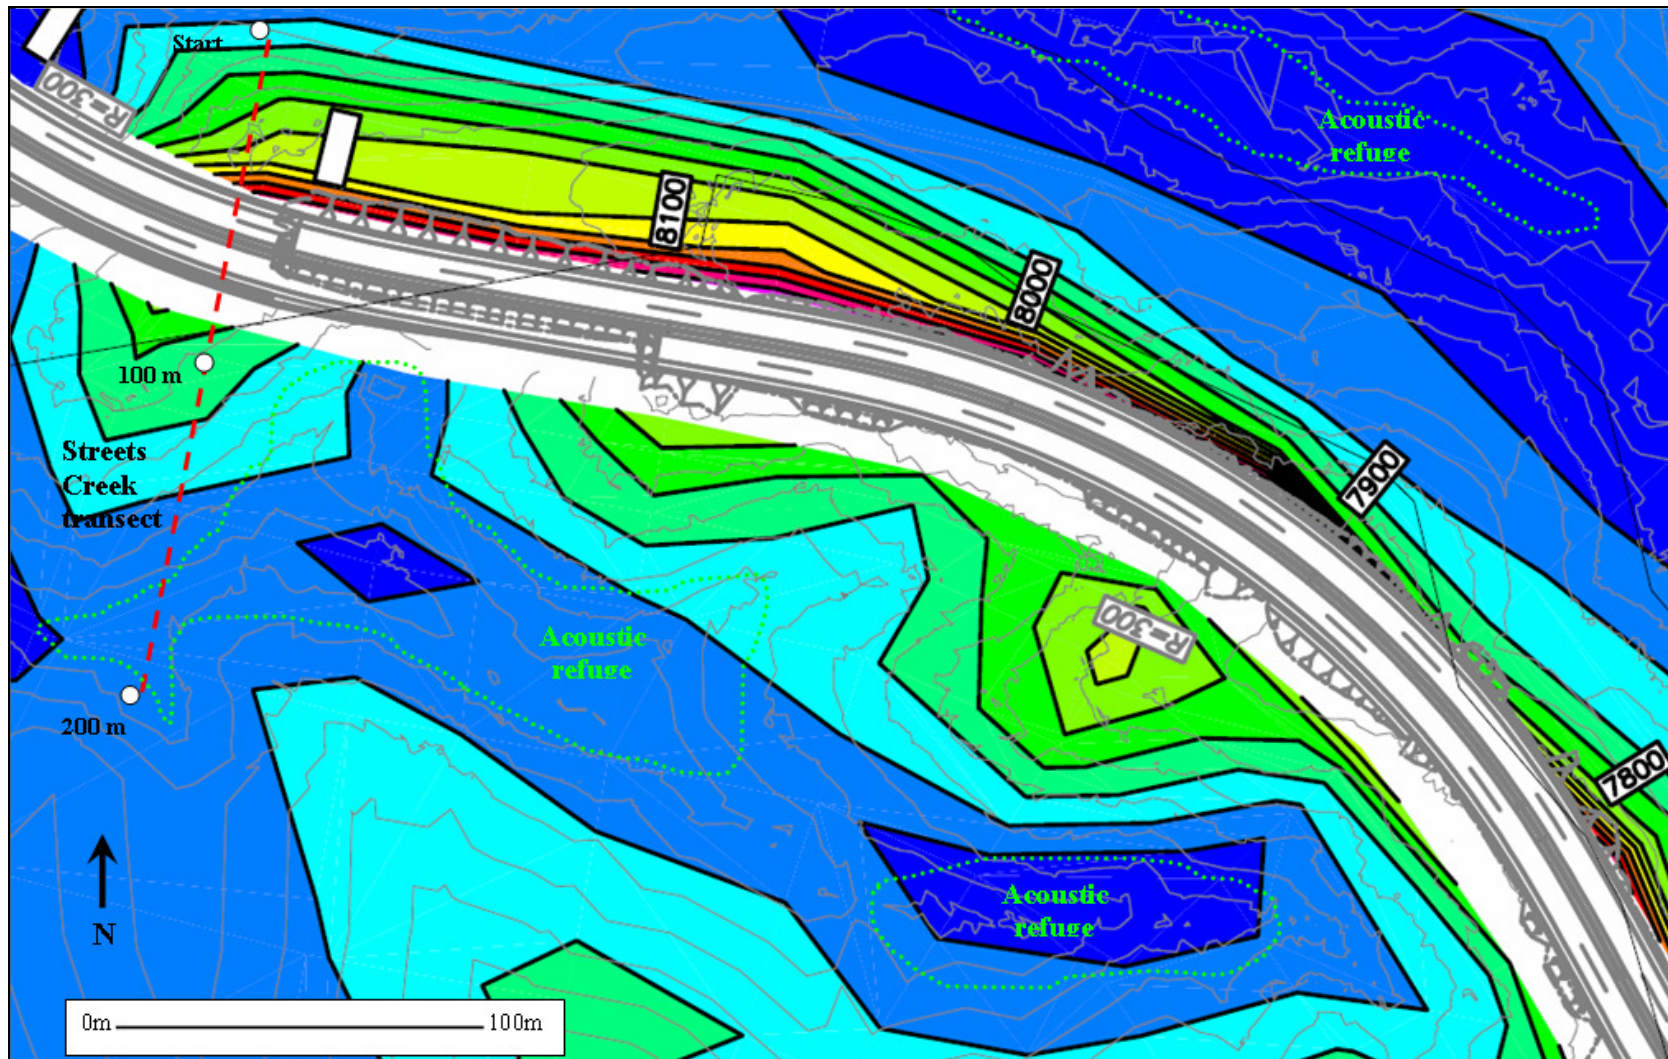
**Figure A2.3.9:** Acoustic refugia, Streets Creek area, Kuranda Range Road (modified from ASK Consulting Engineers 2867FIGA, C5, 2003).

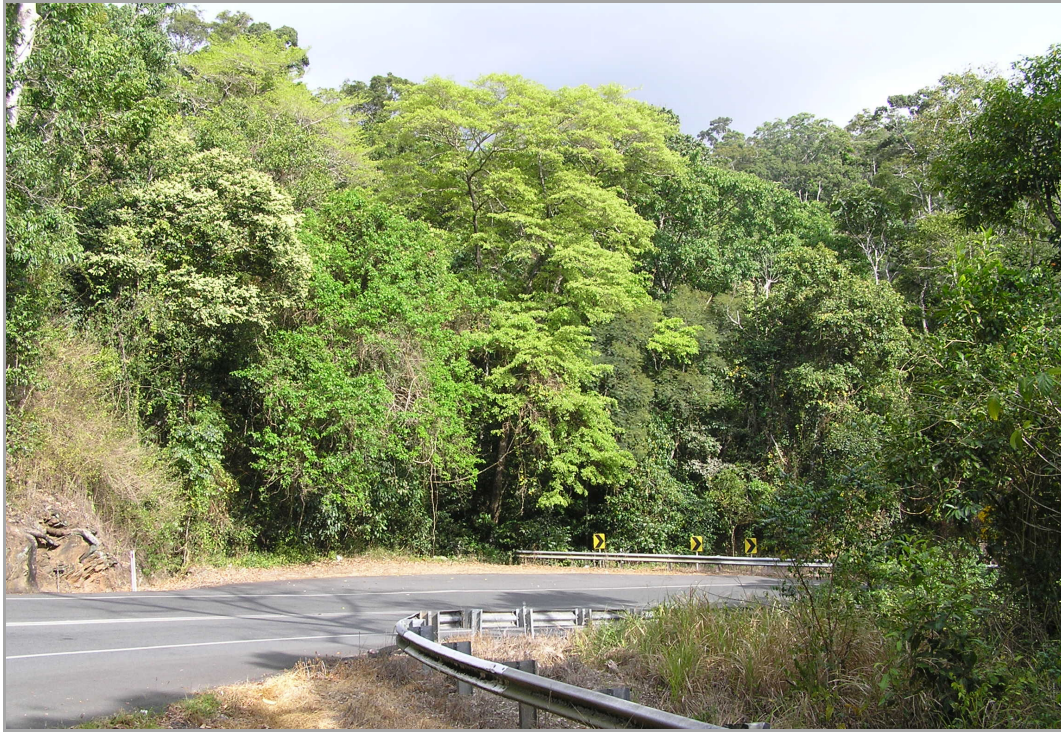
**Figure A2.4.1:** Avondale Creek (AC) transect (starts behind Armco barrier near right traffic arrow). Photograph: Gregory Dawe, 2005.

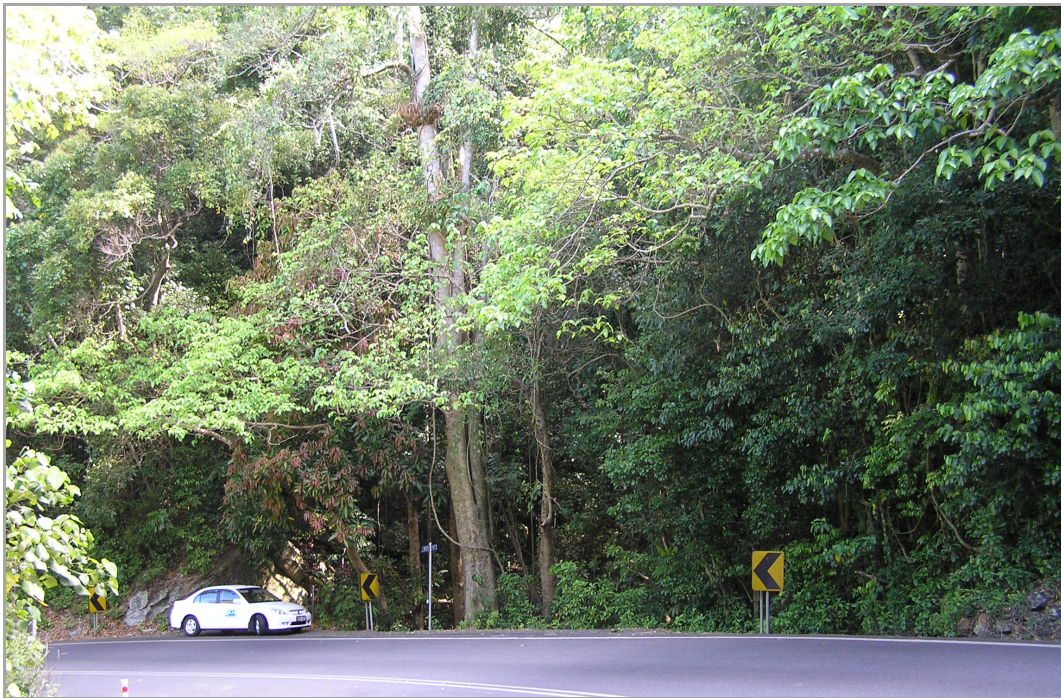
**Figure A2.4.2:** Water Point (WP) transect (starts behind vehicle). Photograph: Gregory Dawe, 2005.

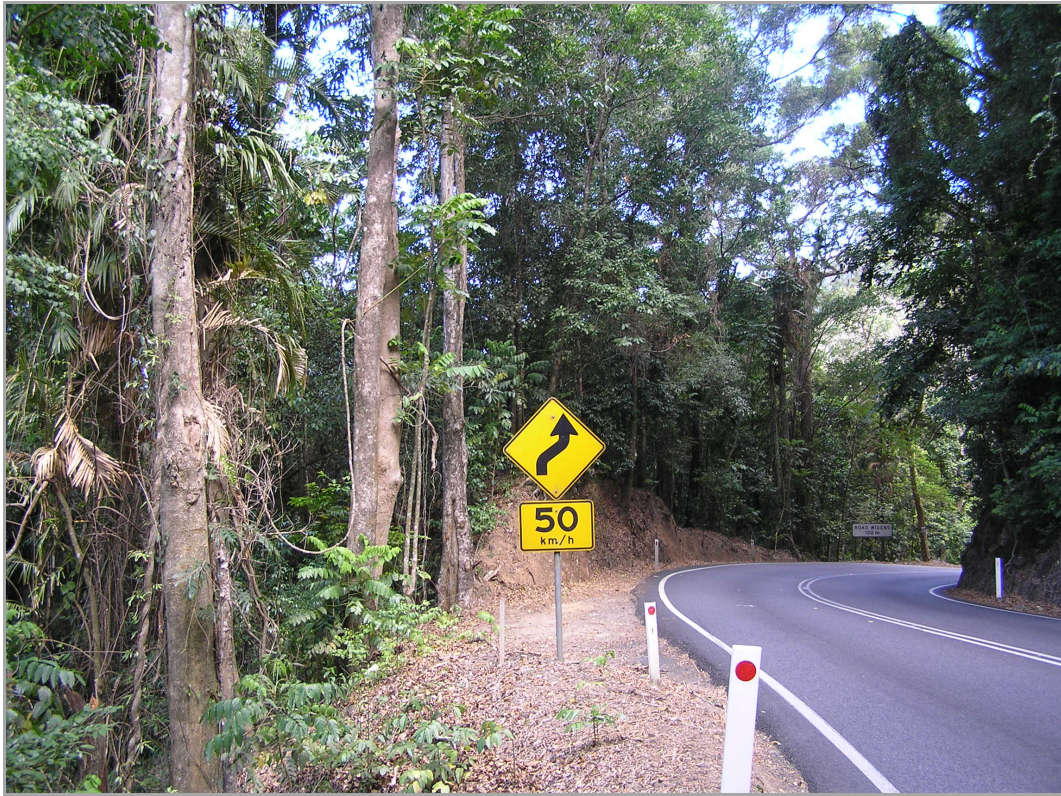
**Figure A2.4.3:** Down Ridge (DR) transect (starts behind 50 km/h sign). Photograph: Gregory Dawe, 2005.

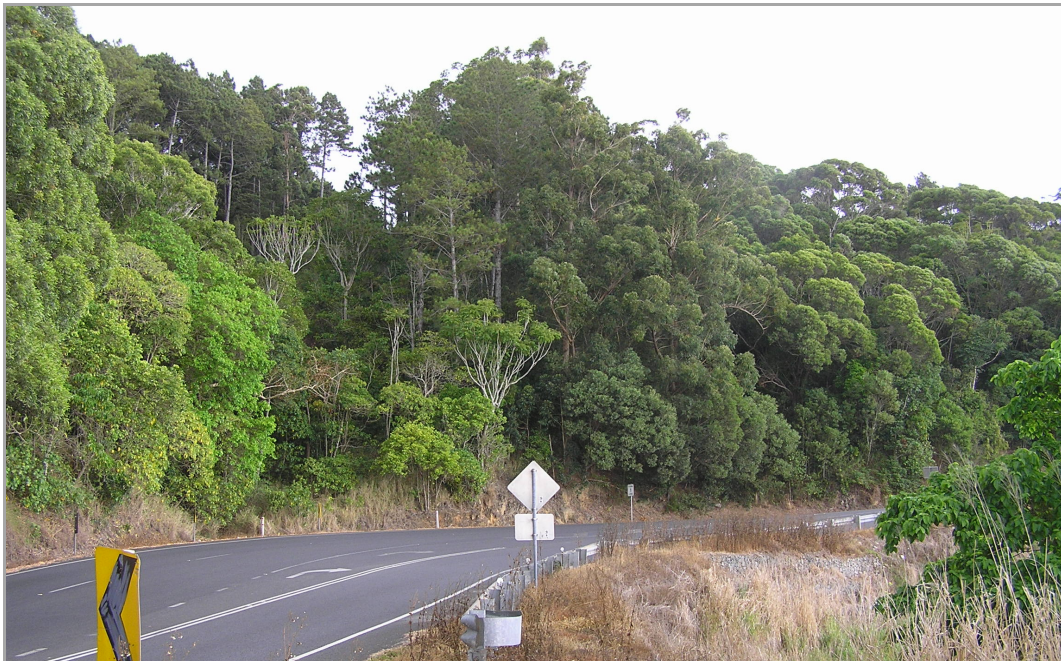
**Figure A2.4.4:** Lookout (LO) transect (starts behind 'Form One Lane' sign at the rear right of this photograph). Photograph: Gregory Dawe, 2005.

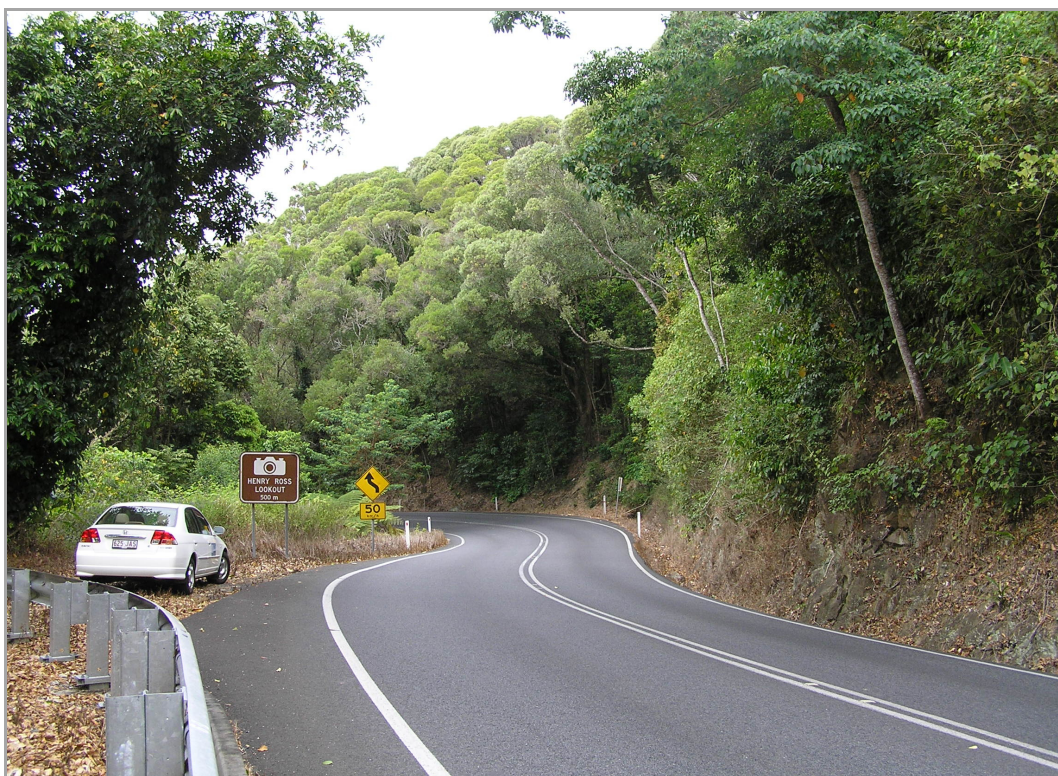
**Figure A2.4.5:** Lookout Sign (LS) transect (transect ascent starts behind guidepost at centre rear of this photograph). Photograph: Gregory Dawe, 2005.

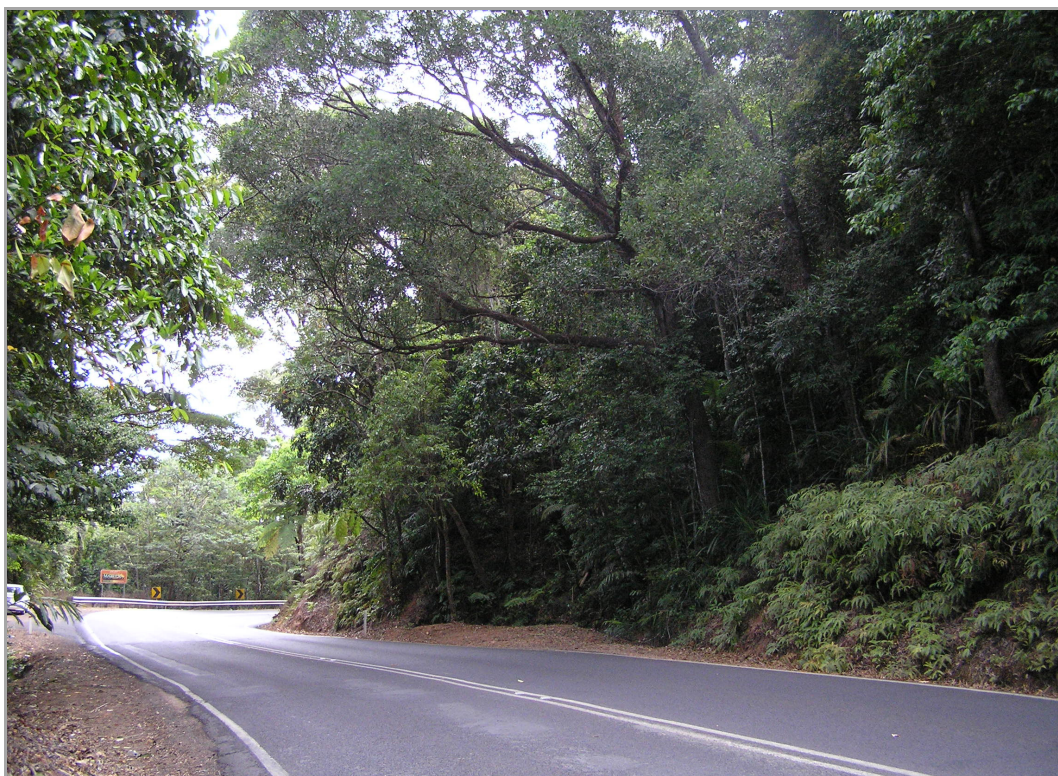
**Figure A2.4.6:** Mareeba Sign (MS) transect (starts behind guidepost at centre of photograph). Photograph: Gregory Dawe, 2005.

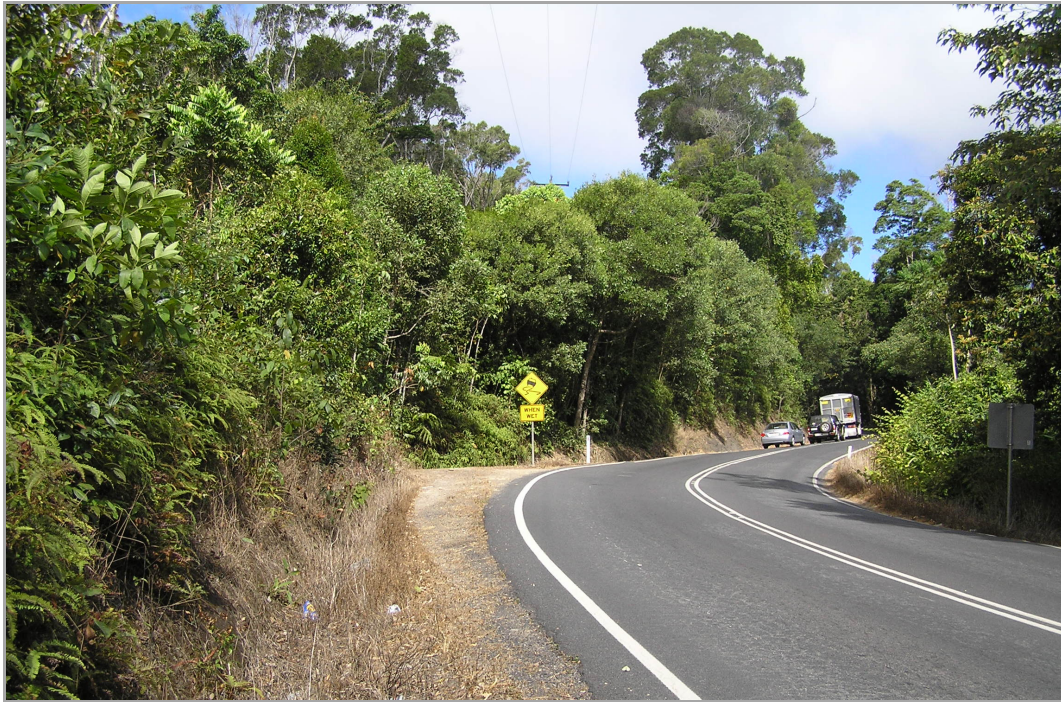
**Figure A2.4.7:** Powerline (PL) transect (starts to the left of 'Slippery When Wet' sign).  
**Note:** powerline above starting point. Photograph: Gregory Dawe, 2005.

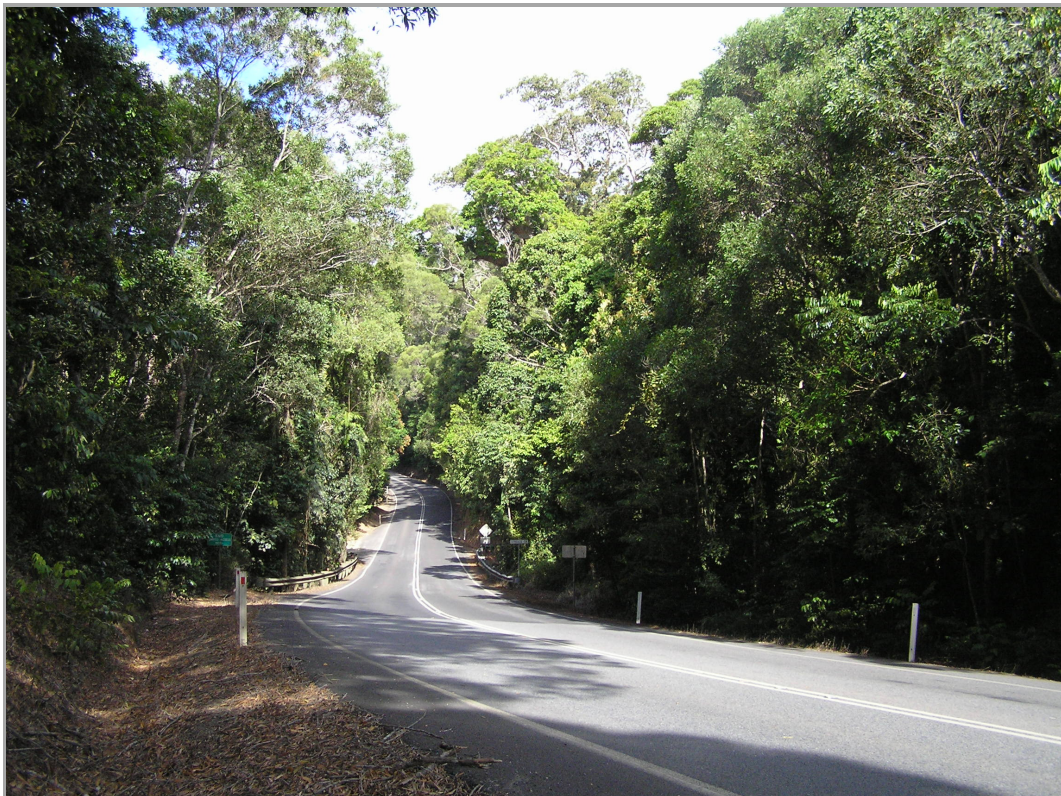
**Figure A2.4:** Streets Creek (SC) transect (starts behind caution sign past bridge).  
Photograph: Gregory Dawe, 2005.

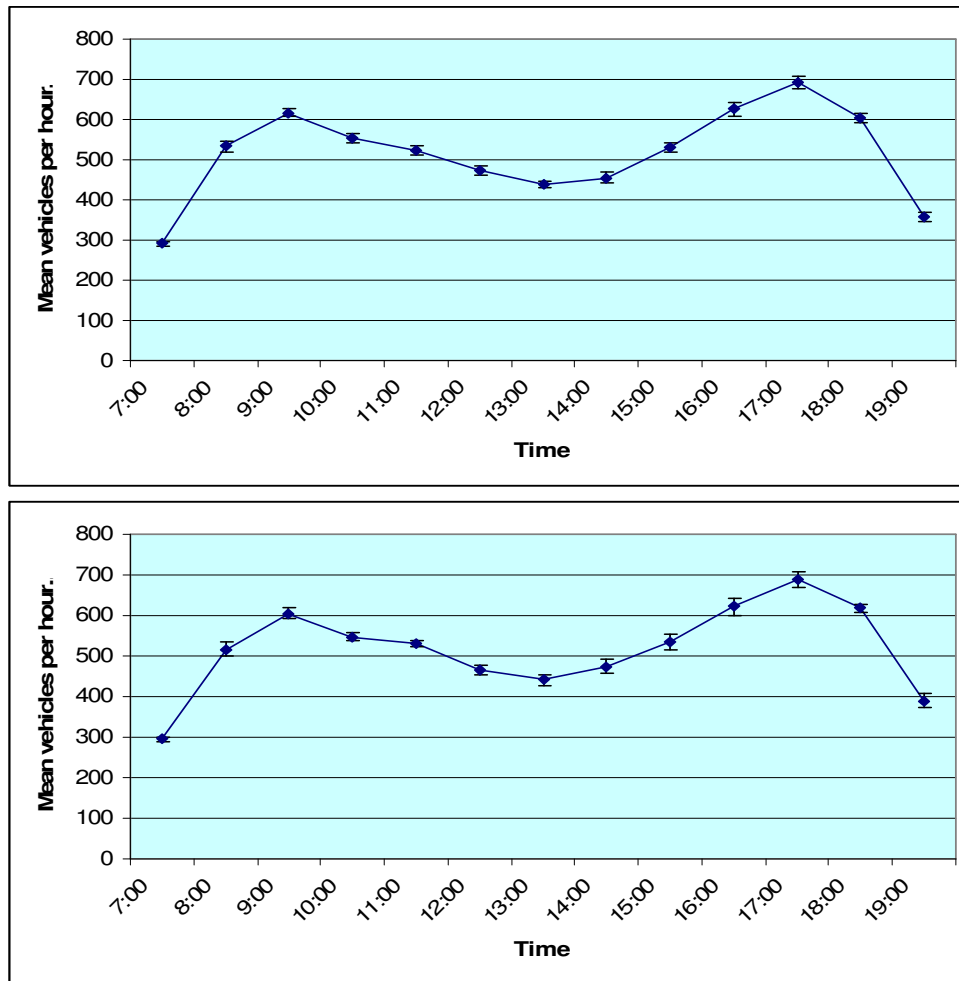
**Figure A.2.5.1:** Mean hourly traffic flows  $\pm 1$  SE corresponding to noise sampling for ground level (*top*) and lower canopy level (*bottom*).

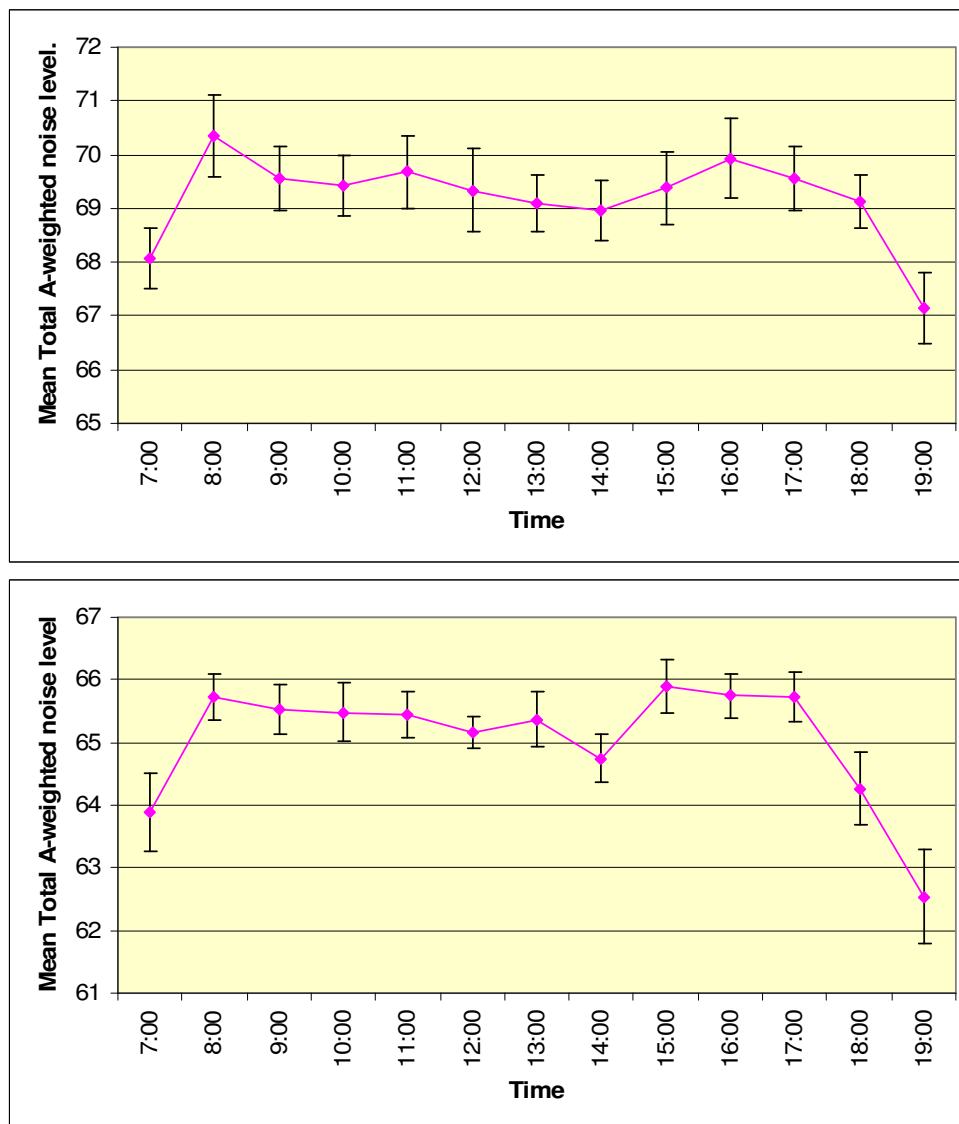
**Figure A.2.5.2:** Mean hourly total A-weighted edge noise levels  $\pm 1$  SE for all transects at ground level (*top*) and in lower canopy (*bottom*).
